# Precise and confident treatment of a complex root fracture

*A complex premolar root fracture case using the new CS 8200 3D Neo Edition CBCT system from Carestream Dental.*

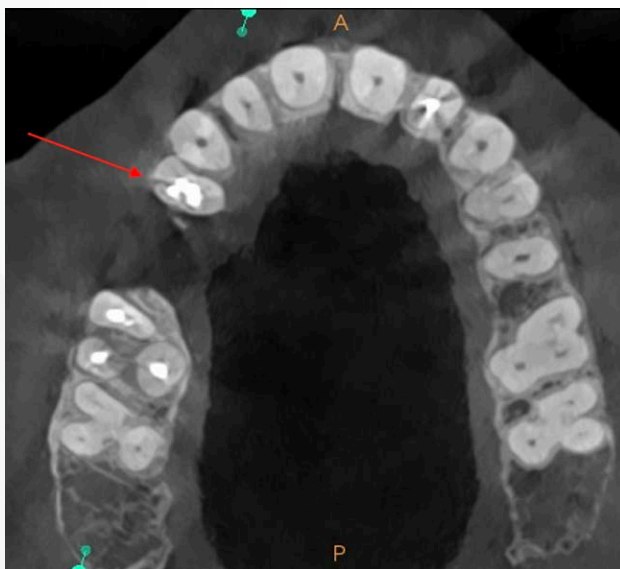
Fig. 1 - Axial view of the maxilla, showing a root fracture of tooth 14 (red arrow)

The images demonstrated bone loss around the sites of the 14 and 16 (Fig 1 and 2), which explained the mobility and positive percussion. Using different 3D views obtained from the CS 8200, complex root fracture was diagnosed in the first premolar (14) (Fig. 3), along with complete bone loss between the roots of the first maxillary molar (16) and a small sinus floor bone perforation (Fig. 4 and 5).

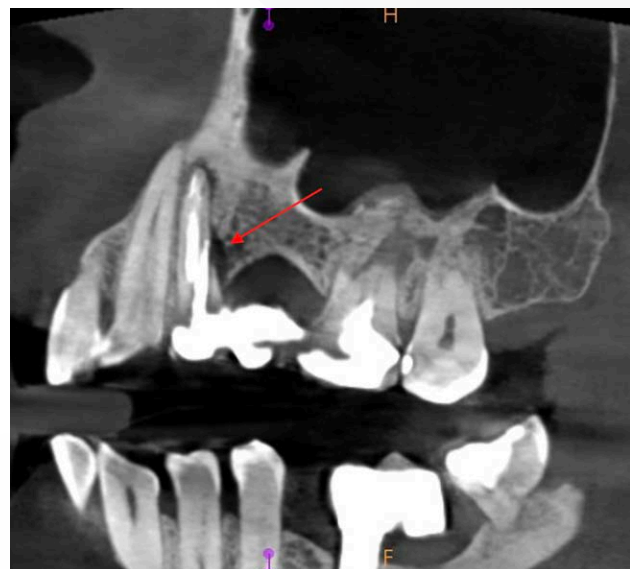
Fig. 2 - Sagittal view showing a root fracture of tooth 14, the bone loss associated (red arrow) and an apical lesion

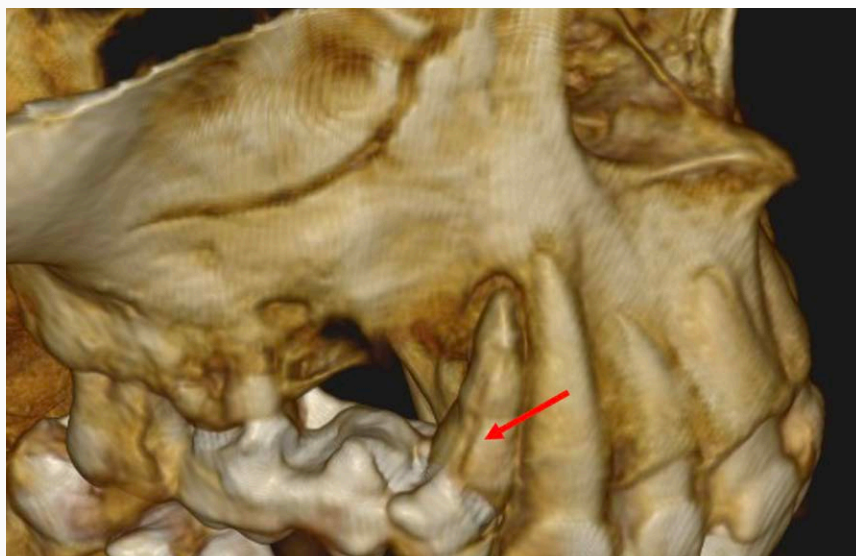
Fig. 3 - 3D rendering showing the vertical root fracture on the vestibular side of tooth 14 (red arrow)

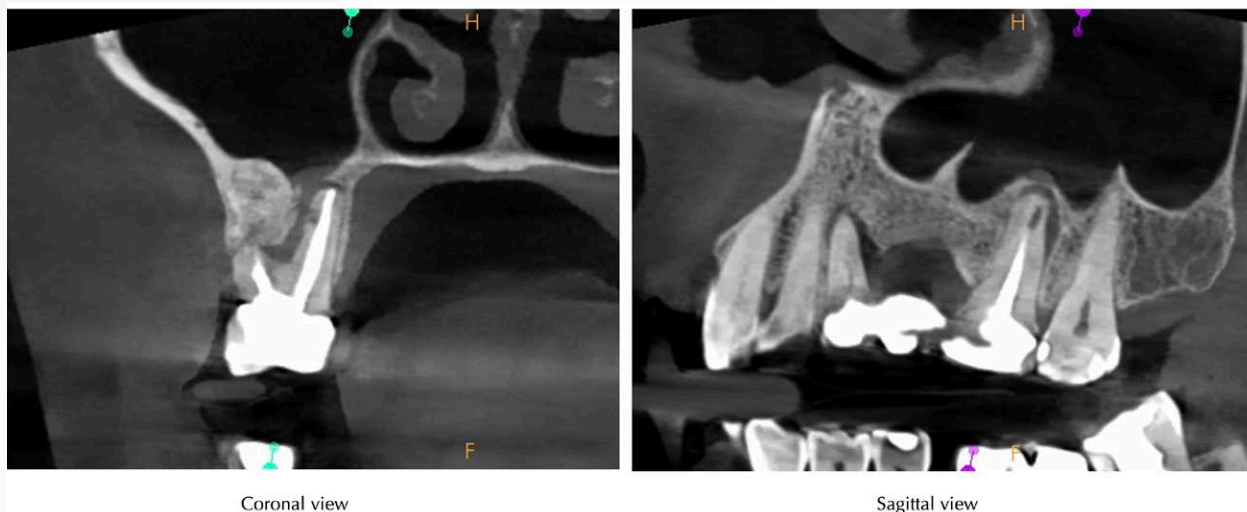
Figs. 4-5 - Coronal and sagittal views of tooth 16, showing the dentine and bone resorption on the palatal root and the sinus floor perforation
